BEFORE THE WESTLAND DISTRICT COUNCIL

**IN THE MATTER of resource consent
applications 220120 &
230030 at 117
Arthurstown Road,
Hokitika**

STATEMENT OF EVIDENCE OF STUART CHARLES CHALLENGER

8 April 2024

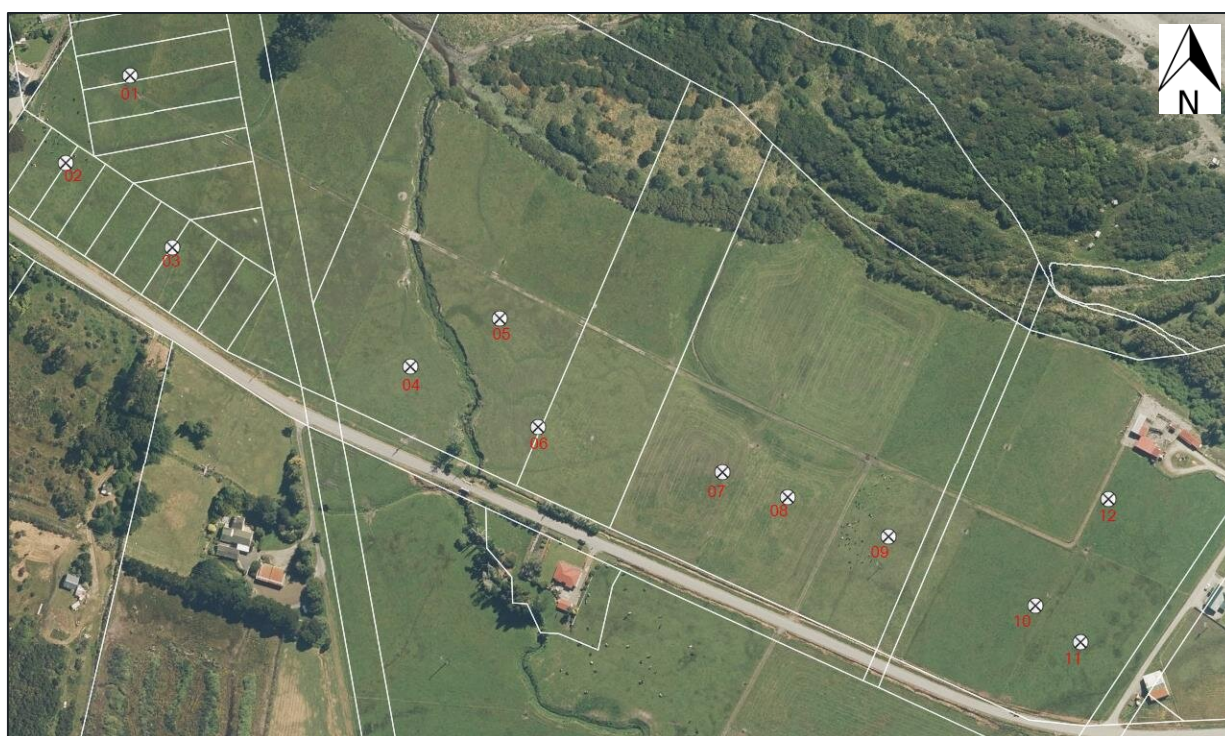
Figure 3. Approximate test locations (Eliot Sinclair, 2022)

On 7th September 2022 a site investigation was undertaken to determine the soil profile and bearing capacity. The investigation included eight test pits, in a grid like pattern across all proposed lots, and 12 dynamic cone penetrometer tests. The results from these tests can be found in Appendix B.

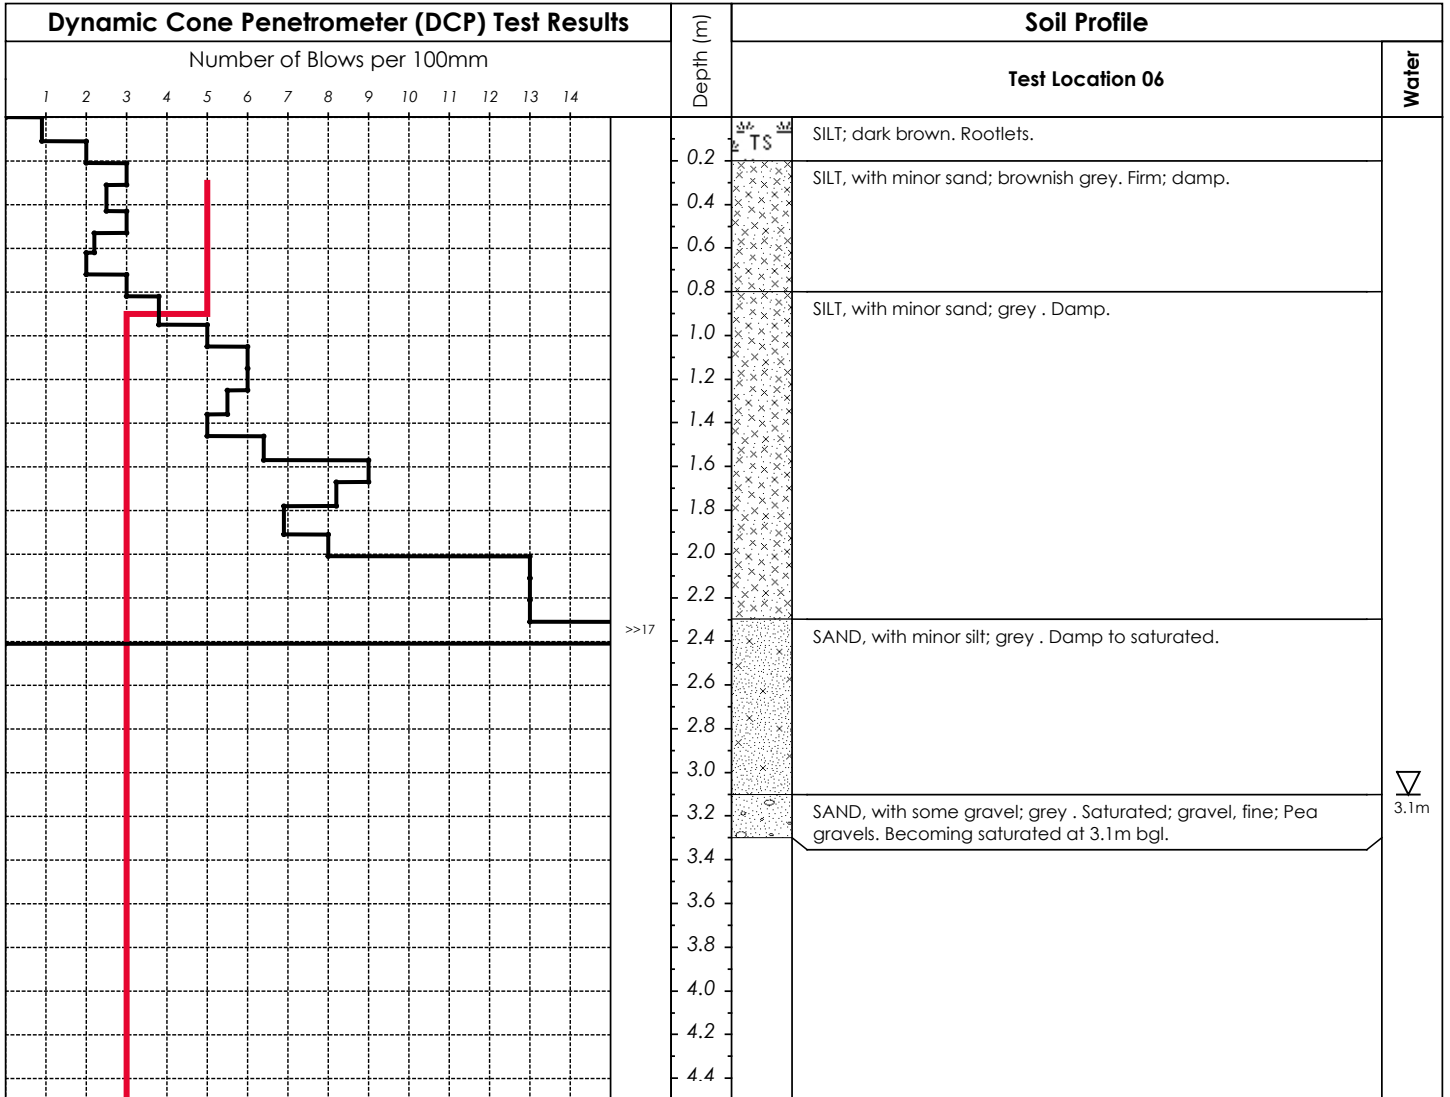
— 06
 Minimum penetration resistance (based on 300mm wide footing founded at 300mm depth) required for 'Good Ground' as defined in the Acceptable Solutions and Verification Methods for NZBC Clause B1 Structure.

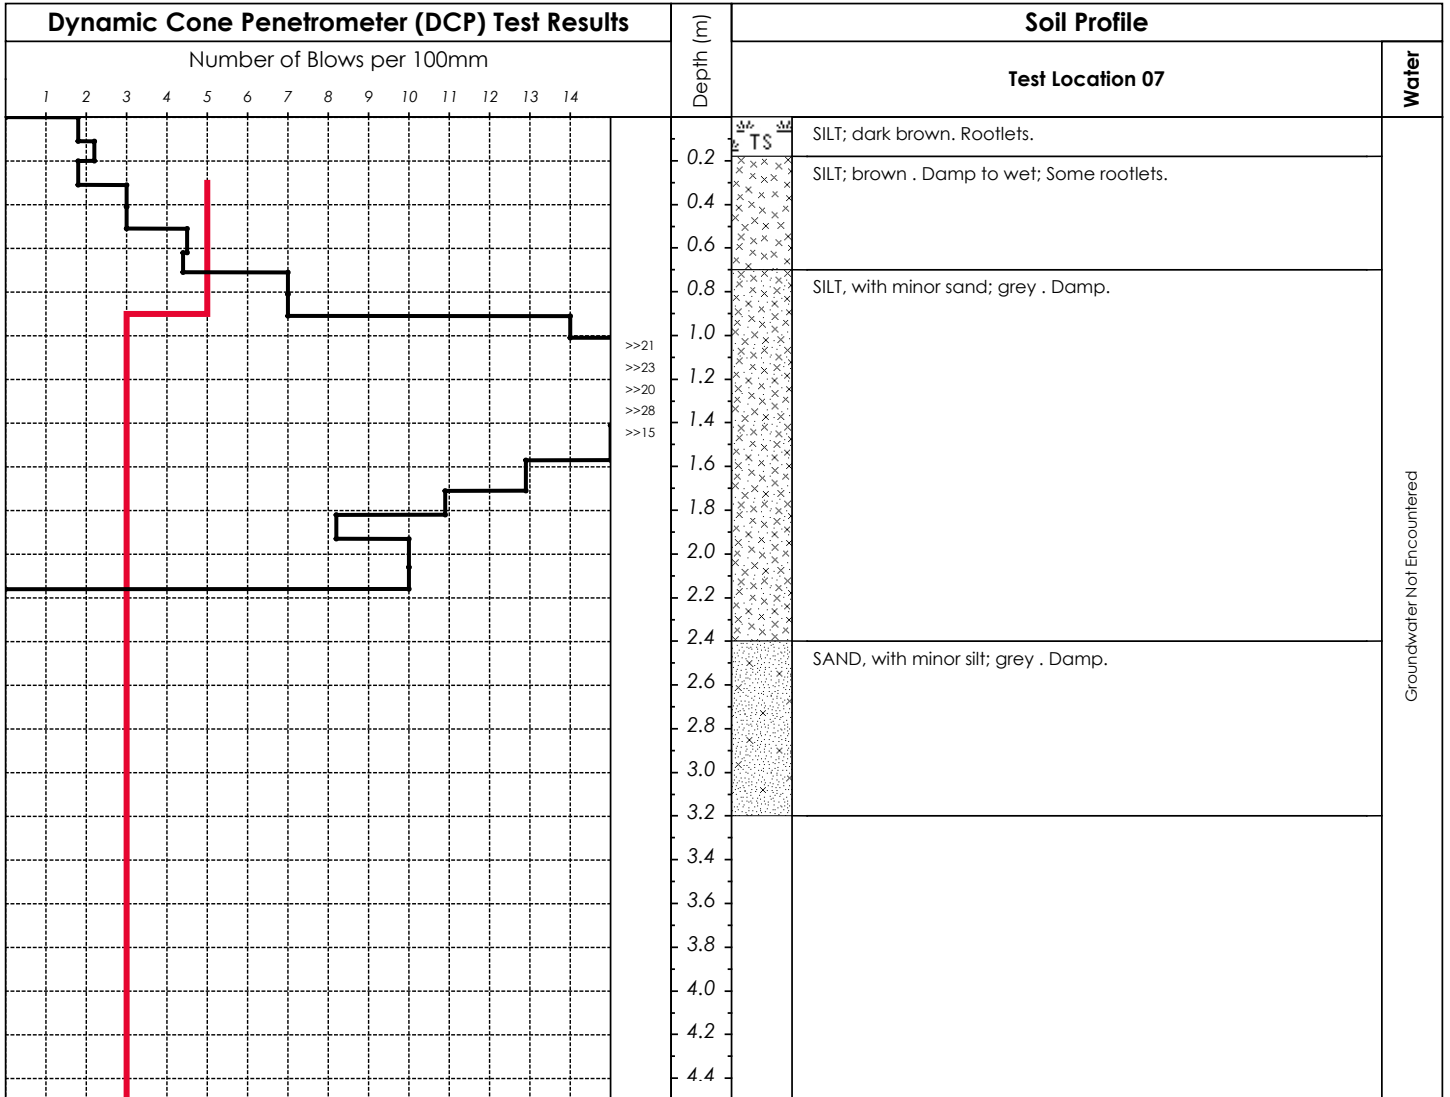
— 07
 Minimum penetration resistance (based on 300mm wide footing founded at 300mm depth) required for 'Good Ground' as defined in the Acceptable Solutions and Verification Methods for NZBC Clause B1 Structure.

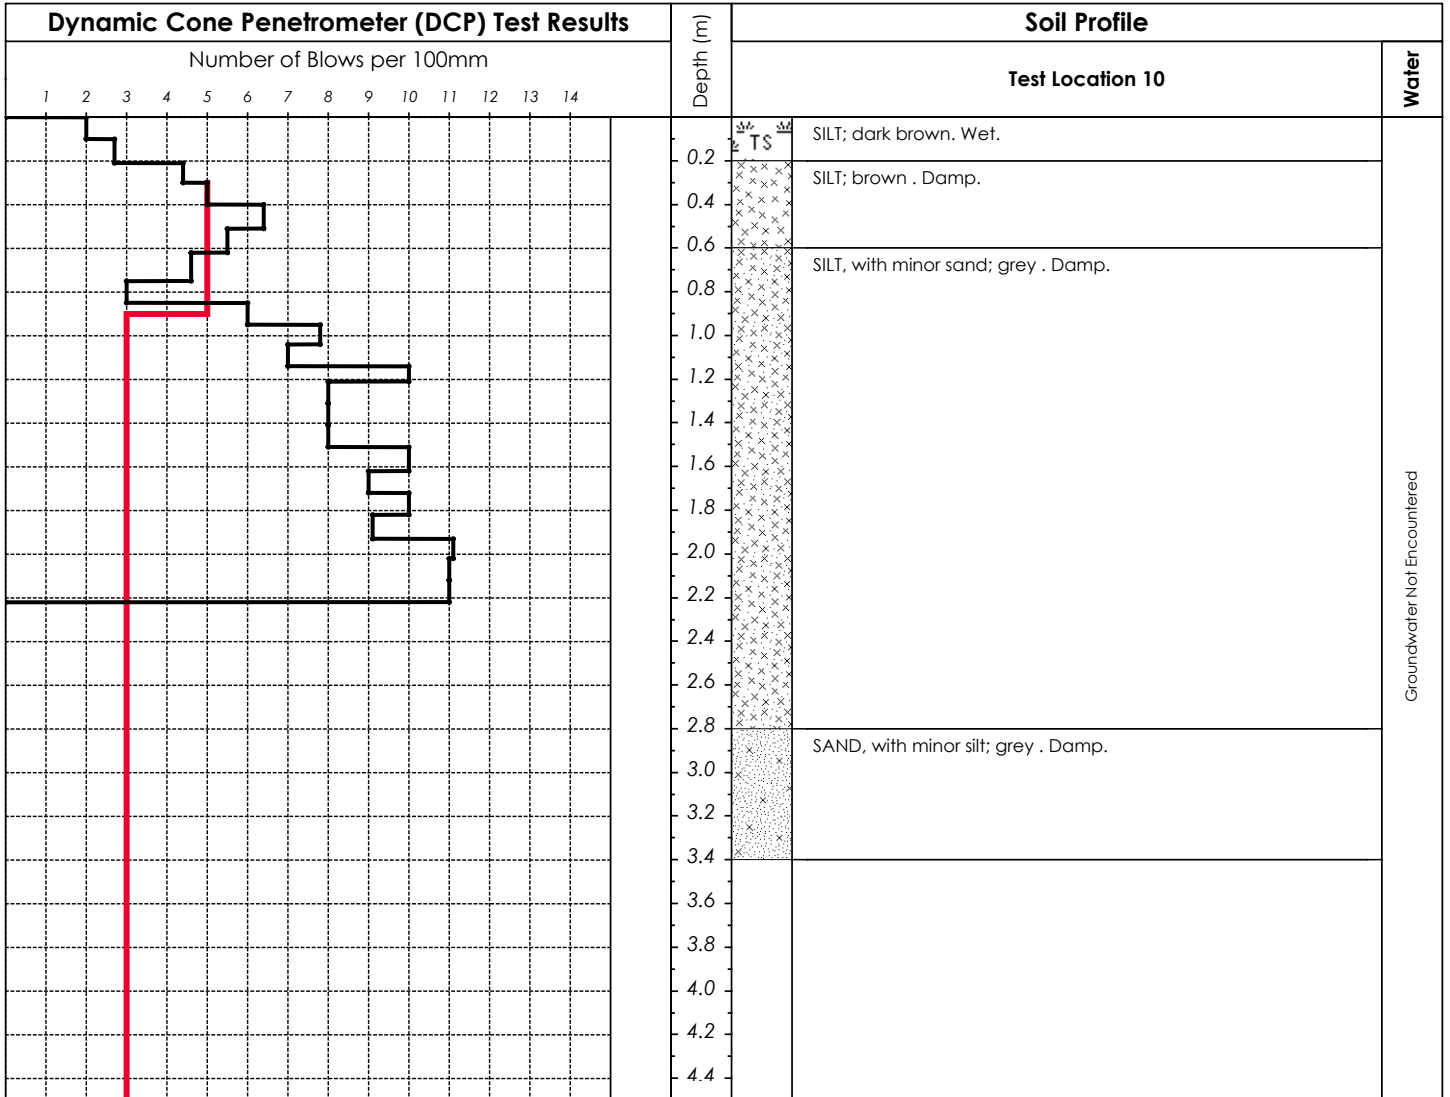
— 10
 Minimum penetration resistance (based on 300mm wide footing founded at 300mm depth) required for 'Good Ground' as defined in the Acceptable Solutions and Verification Methods for NZBC Clause B1 Structure.

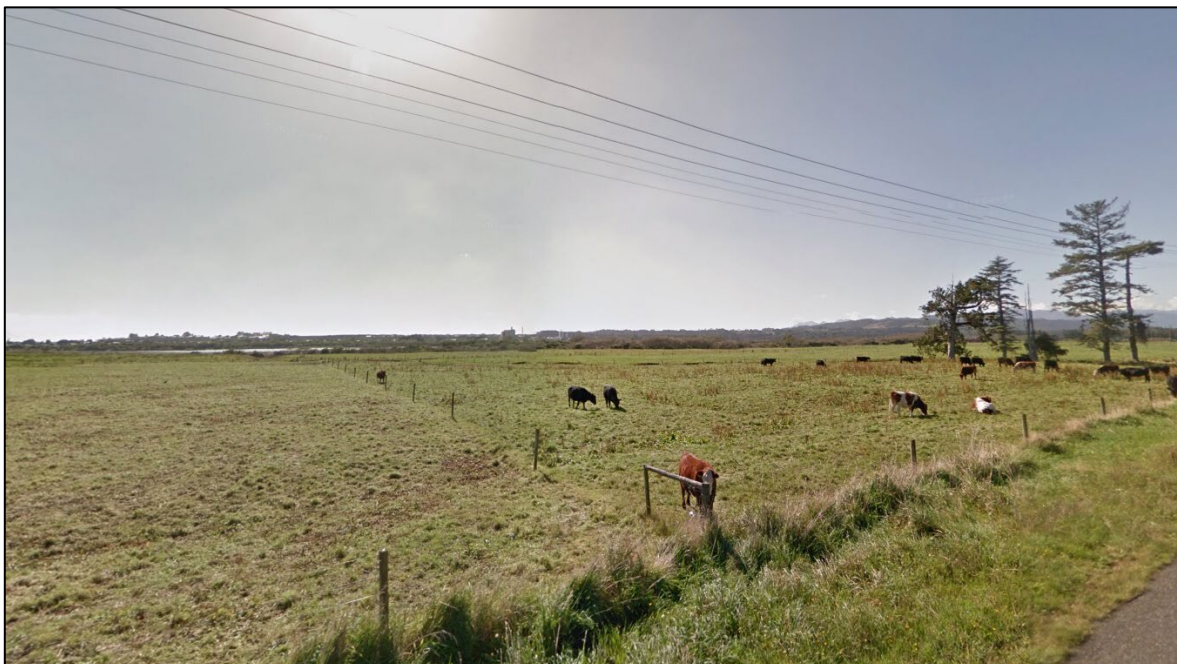
The 19 hectare (or there-about) site is located on the northern side of Arthurstown Road approximately 1.0 km east of its intersection with Ruatapu Road (SH6), Hokitika. The property is on the southern side of the Hokitika river mouth. The site comprises pastural grazing and is relatively level at an elevation of between around RL3.0m and RL5.0m. The site drains gently towards the north to the Hokitika River. The site is subject to flood inundation during peak river flood flows.

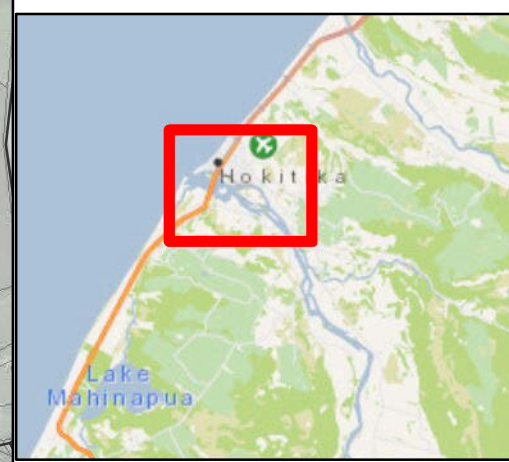
Map 1 of 3

Hazard Category
 H6
 H5
 H4
 H3
 H2
 H1

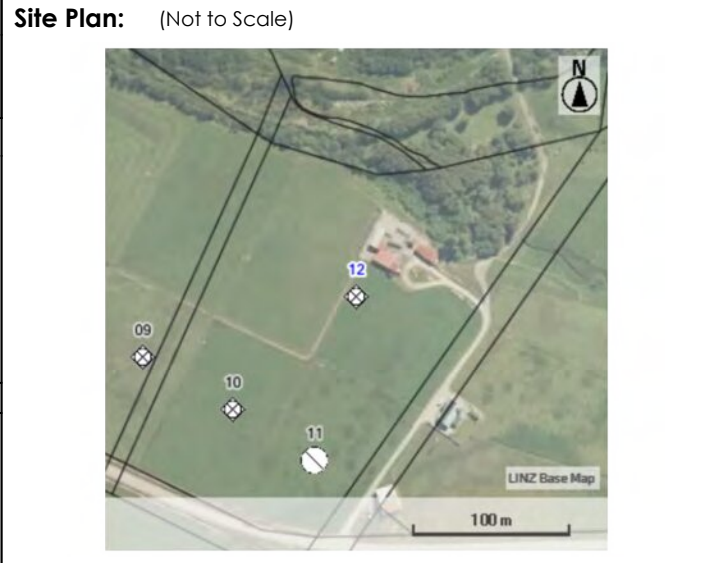
— 12
 Minimum penetration resistance (based on 300mm wide footing founded at 300mm depth) required for 'Good Ground' as defined in the Acceptable Solutions and Verification Methods for NZBC Clause B1 Structure.

Comments:
 Dynamic Cone Penetrometer: Lot 12

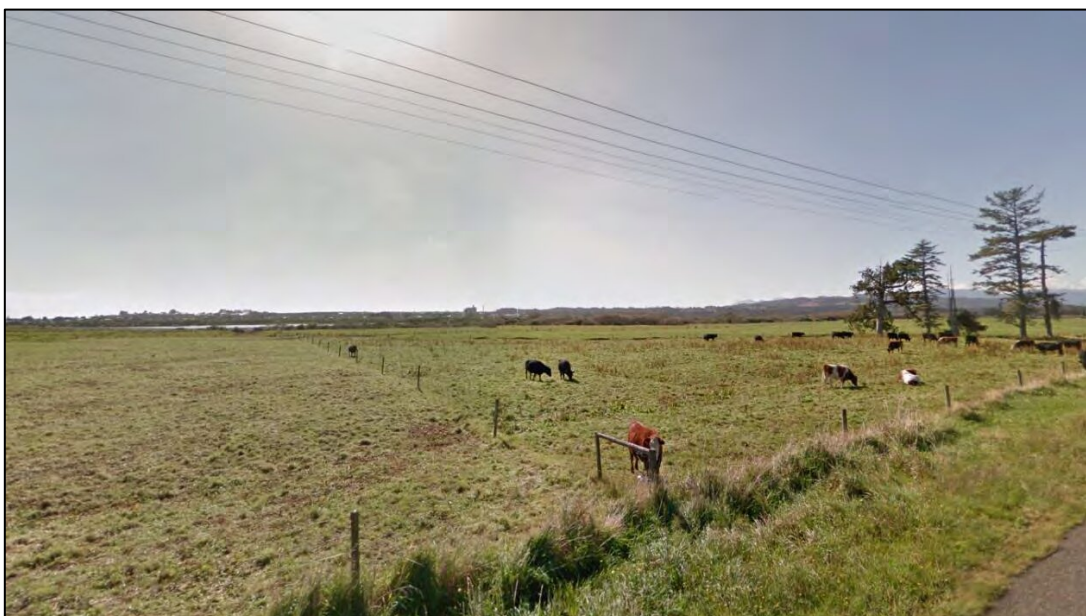
The 19 hectare (or there-about) site is located on the northern side of Arthurstown Road approximately 1.0 km east of its intersection with Ruatapu Road (SH6), Hokitika. The property is on the southern side of the Hokitika river mouth. The site comprises pastoral grazing and is relatively level at an elevation of between around RL3.0m and RL5.0m. The site drains gently towards the north to the Hokitika River. The site is subject to flood inundation during peak river flood flows.

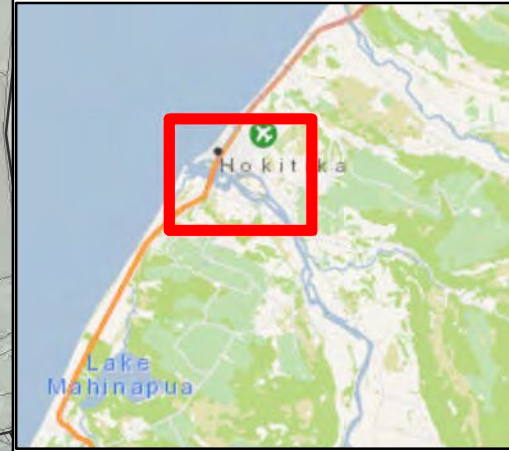
Map 1 of 3

APPENDIX C
Hokitika River Flood Modelling – Hazard Map

H1 - Generally safe for vehicles, people and buildings
 H2 - Unsafe for small vehicles
 H3 - Unsafe for vehicles, children and the elderly
 H4 - Unsafe for vehicles and people
 H5 - Unsafe for vehicles and people
 All buildings vulnerable to structural damage
 Some less robust buildings subject to failure
 H6 - Unsafe for vehicles and people
 All building types considered vulnerable to failure

MAP TITLE **HAZARD MAP**
 1 in 100 year event including climate change (2100)
 RCP Scenario 6.0, 1m Sea Level Rise, 0.4m Storm Surge

The same flood modelling report defines flood risk on the Hazard Map for most of the site as H1 and H2, generally safe for vehicles, people buildings, and unsafe for small vehicles respectively, refer Appendix C.
